Passive Acoustic Monitoring off Southern
California using Autonomous Underwater
Vehicles: Summary of Technical Issues
Encountered, Lessons Learned, and Future
Recommendations

Contract No. N62470-15-D-8006
Task Order 18F0147

Appendix A – Manufacturer's Post- Recovery Diagnostic Report for Glider SG639

SEAGLIDER "SG639" SERVICE REPORT

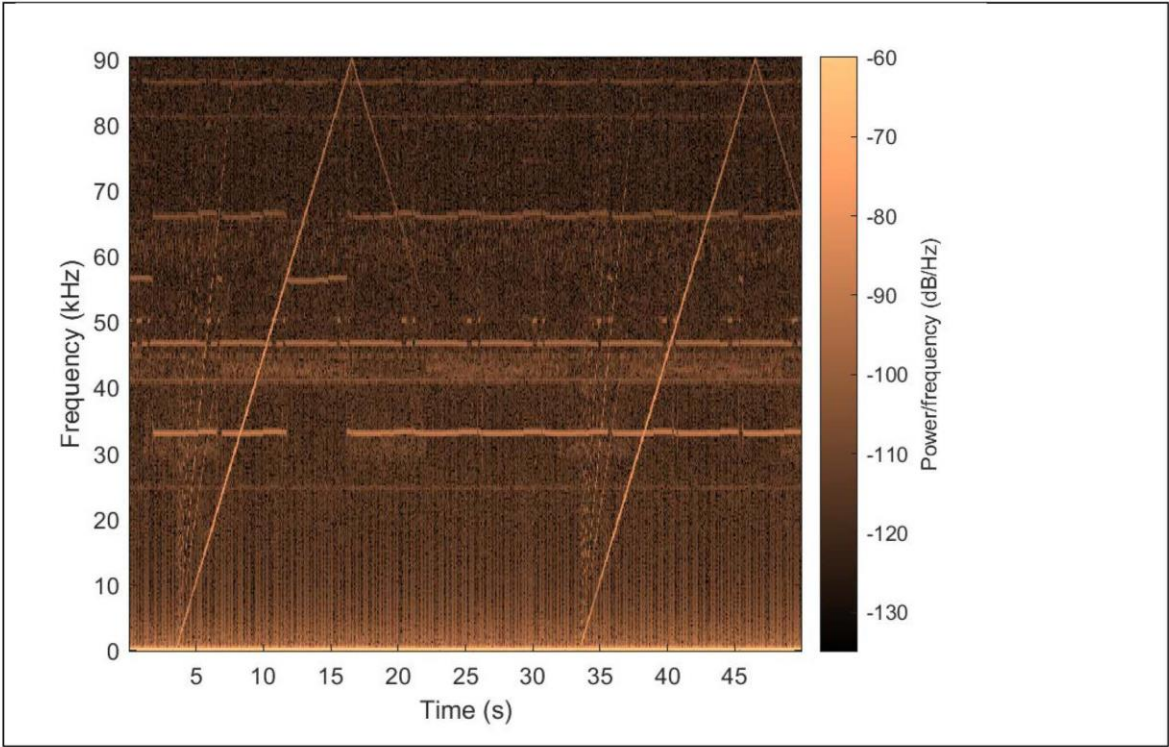
To test the system, a signal generator hooked up to an antenna was used. Recordings were generated during simulated dives with both the hydrophone and signal generator antenna submersed in a garbage can of water to isolate the signal picked up. Sweeps from 1kHz-200kHz over 30 second intervals were used for the testing to analyze the upper frequency limit of the PMAR. Below, the spectrogram shows that the PMAR was able to pick up signal to ~90kHz.
